# Safety Inspection Report

Annual Inspection

## The Swerford Playing Fields

07 August 2023

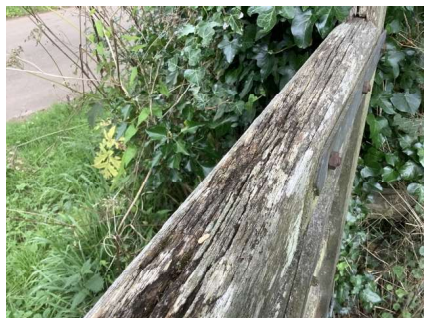
There is decay to timber components which may affect structural integrity. We do not recommend replacing rotten supports with timber posts which are directly set in the ground due to the increased problem of timber rot, especially in posts in contact with the ground.

Decay to gate and posts. Monitor and replace when necessary.

Read the notes for further action.

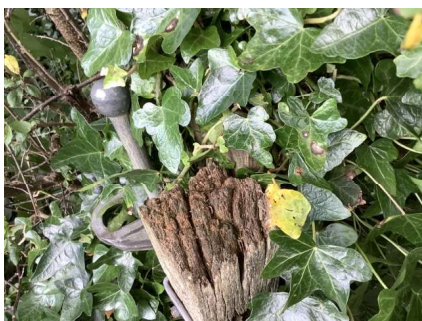
There is a crushing or shearing point on the side of the gate. Where the gaps reduce to less than 12 mm these have been known to cause serious, permanent injury to children, especially on the hinge side where the leverage forces are significant.

Adjust gate / posts / fit new rubber buffer to ensure a spacing of at least 12 mm throughout the range of the gate to remove the entrapment. The 12 mm gap also should apply on the hinge side of the gate.

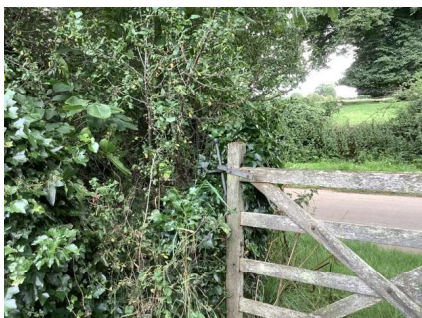
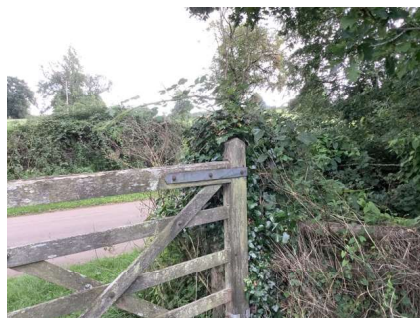
Encroaching vegetation or trees.

Remove.

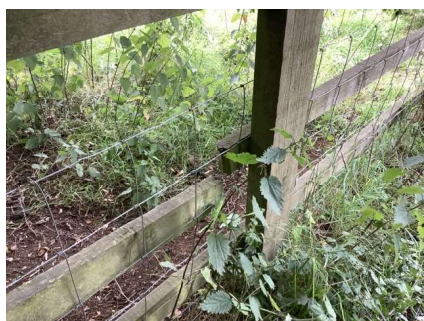
Minor repairs are needed.

Repair.

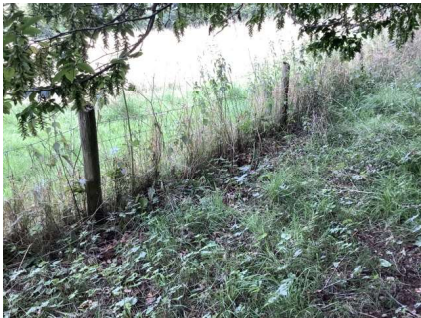
Timber is decayed.

Various parts of the fencing is decaying. Monitor and replace when necessary.

Replace affected parts.

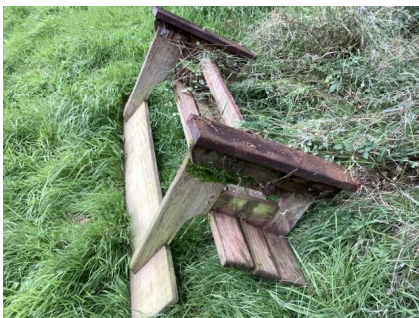
Loose in ground.

Reset.

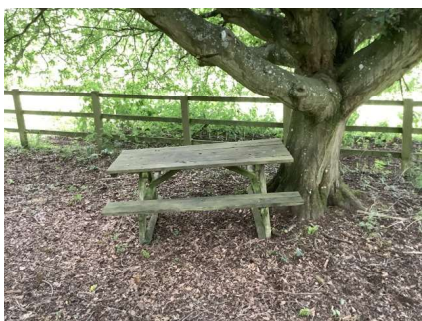
The position of the picnic table enables younger children to gain access to the tree. Reposition the table, thus allowing only those capable of tree climbing to gain access to the tree.

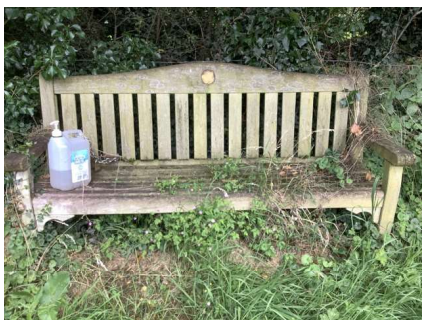
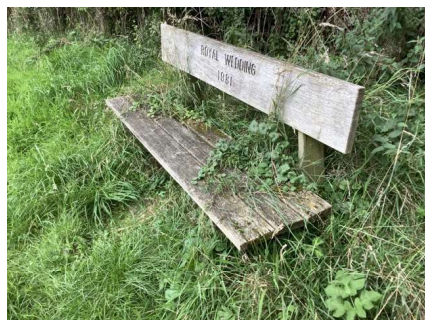
Encroaching vegetation or trees.

Remove.

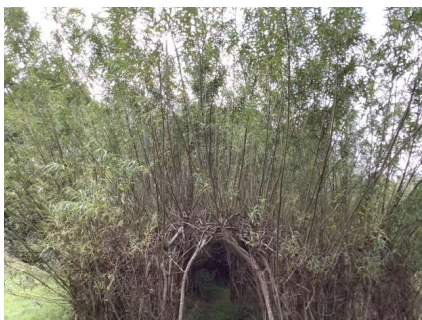
Willow tunnel is in need of pruning and re-shaping.

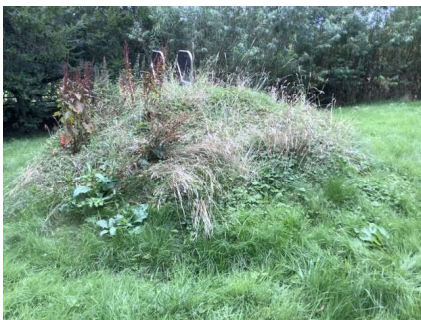
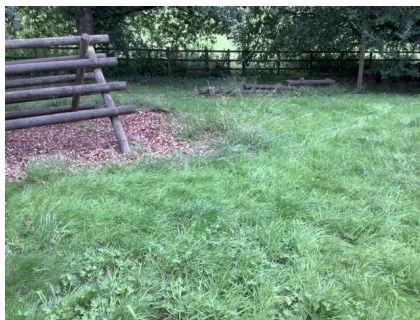
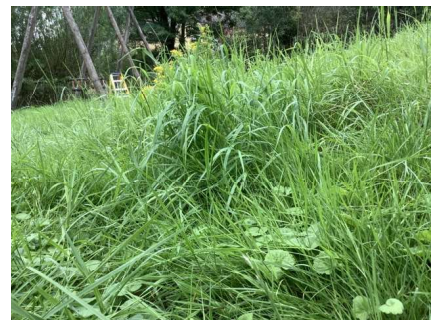
The grass requires cutting / mowing.

Mow the grass.

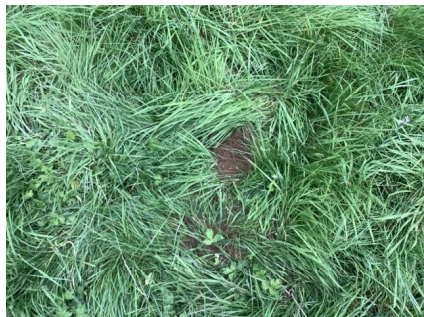
Mole hills present.

Eliminate.

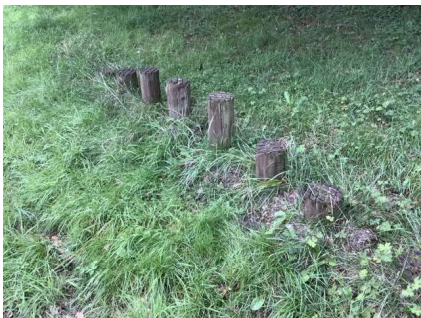
Loose in ground.

Stepping posts are loose in ground. Reset.

Reset.

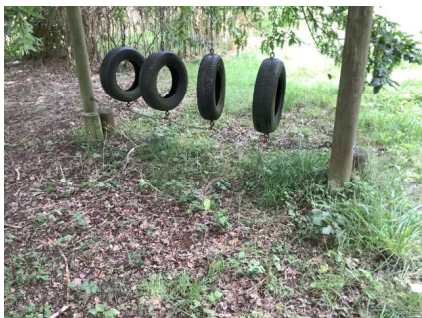
Timber is rotting.

Timbers are softening up at and below ground level. Monitor for structural stability and replace when necessary.

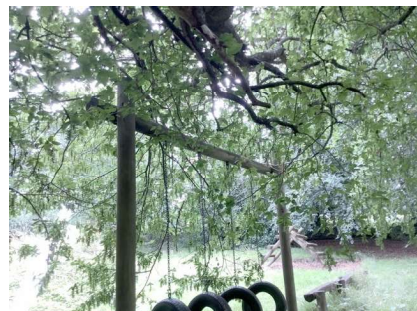
Overhanging tree branches are present.

Cut back.

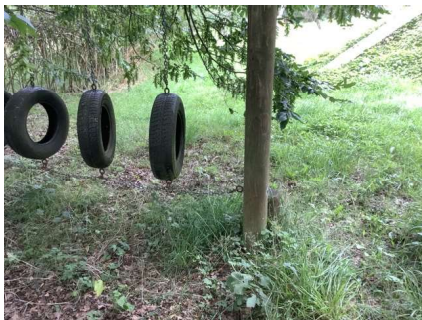
The supports are loose in the ground.

Tyre walk support x 1 is loose in ground. Reset.

Re-set.

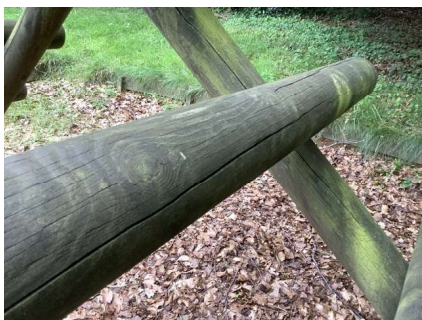
There are natural splits / shakes in the timbers.

Shakes vary. Monitor and consult manufacturer if dimensions exceed 8 mm at sections used to grip / grasp.

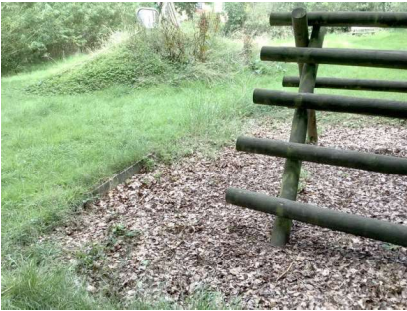
There is an obstacle in the falling space or minimum space.

Timber edging. Monitor.

No reasonably practicable action is identified.

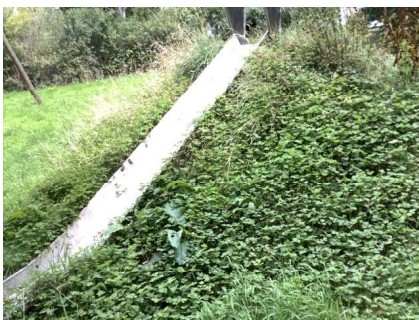
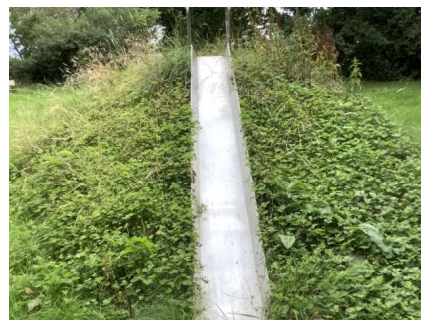
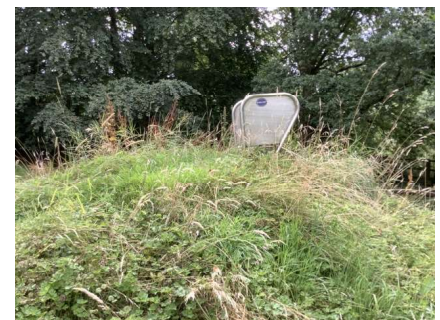
Excessive weed growth on surfacing.

Mechanical removal is recommended.

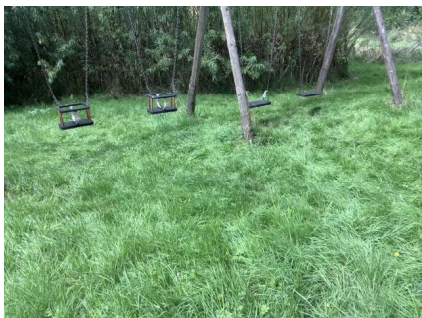
Suitably well maintained grass and topsoil with at least 150 mm of soil beneath is acceptable to EN 1176 for items with a fall height of up to 1.5 metres, subject to a risk assessment.

This unit has a fall height in excess of 1.5m, so the grass is not suitable and a protective surface is required.  
The risk will vary as the grass changes impact absorbency throughout the year.

Install safer surface.

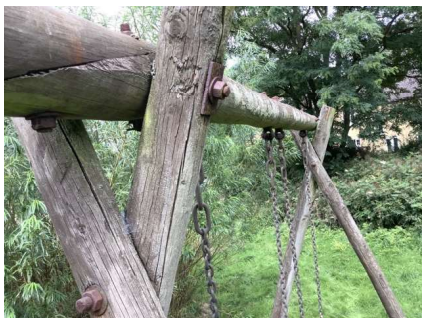
Timber is decayed.

Top beam has various parts that sound dull when tap tested. Monitor for structural stability and replace when necessary.

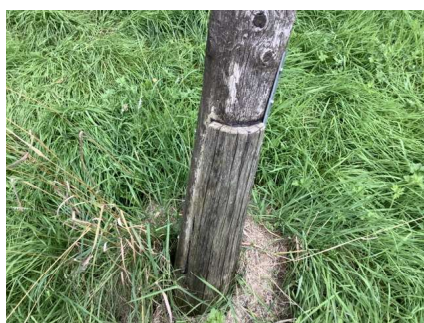
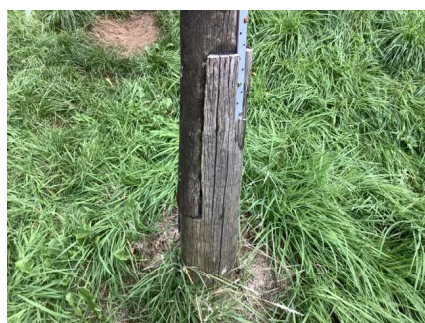
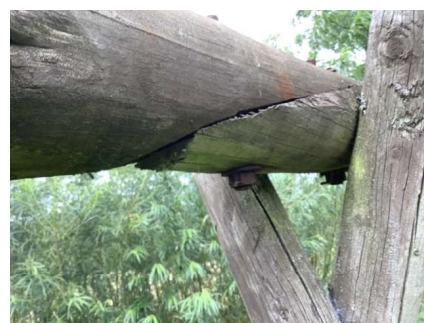
Timber is not in good condition.

A number of significant repairs have been undertaken including splicing in replacement lower legs. There will be a requirement for the operator to check all timber supports and top beam on a routine basis.

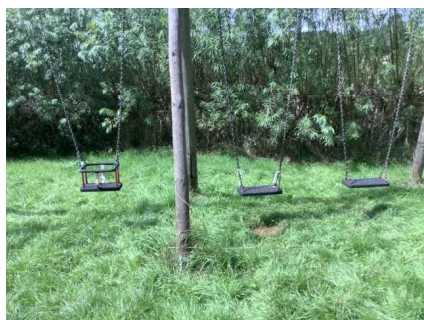
The distance between the seat side and the support is insufficient.

Monitor.

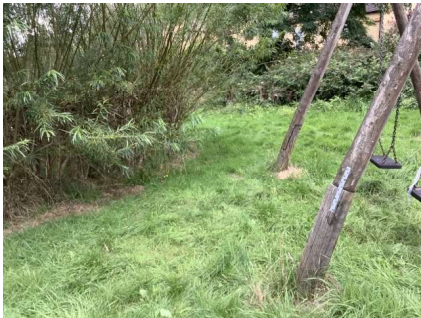
There is an obstacle in the falling space or minimum space.

The willow is within the impact area. Monitor.

No reasonably practicable action is identified.
