# Safety Inspection Report

Annual Inspection

## The Swerford Playing Fields

07 August 2023

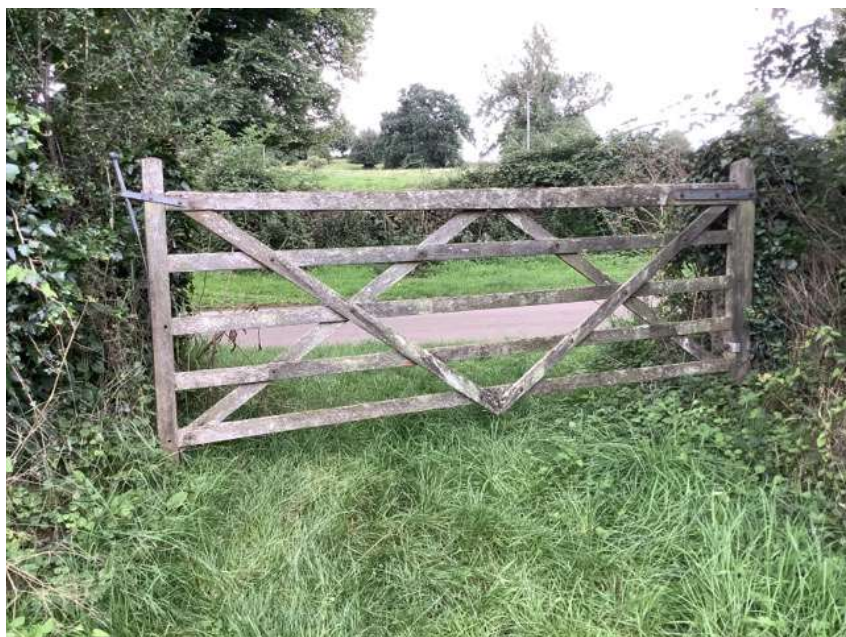
# Gate

There is decay to timber components which may affect structural integrity. We do not recommend replacing rotten supports with timber posts which are directly set in the ground due to the increased problem of timber rot, especially in posts in contact with the ground.

Decay to gate and posts. Monitor and replace when necessary.

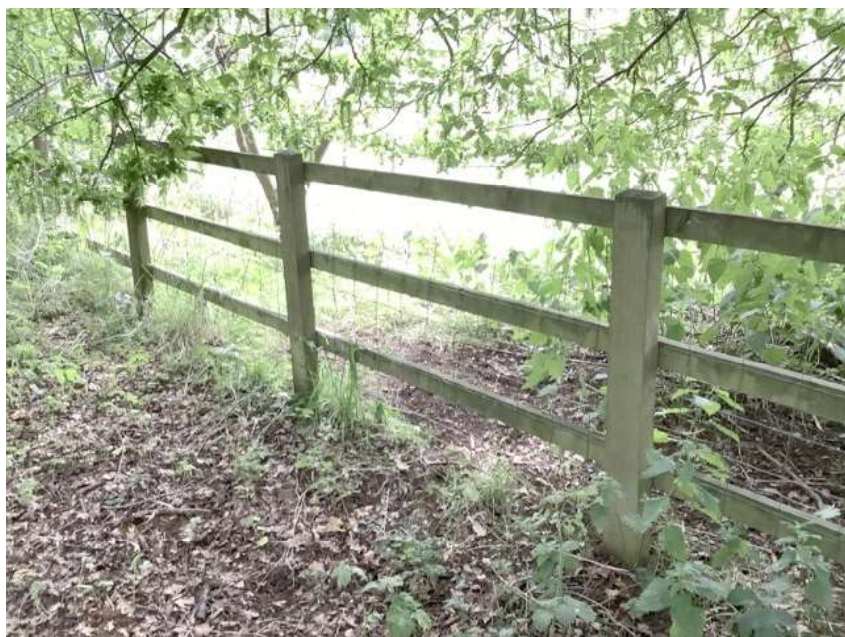
# Fencing

Timber is decayed.

Various parts of the fencing is decaying. Monitor and replace when necessary.

Replace affected parts.

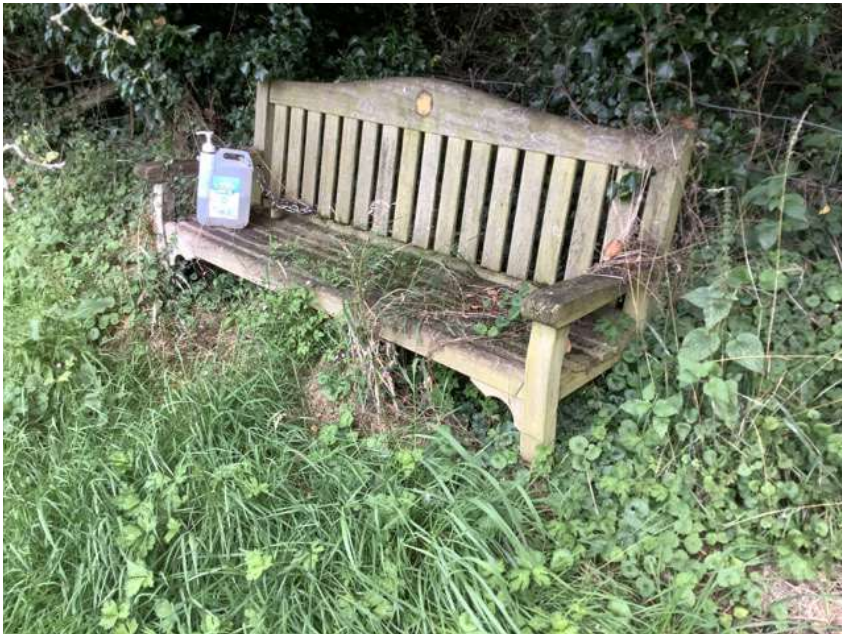
# Seating

Loose in ground.

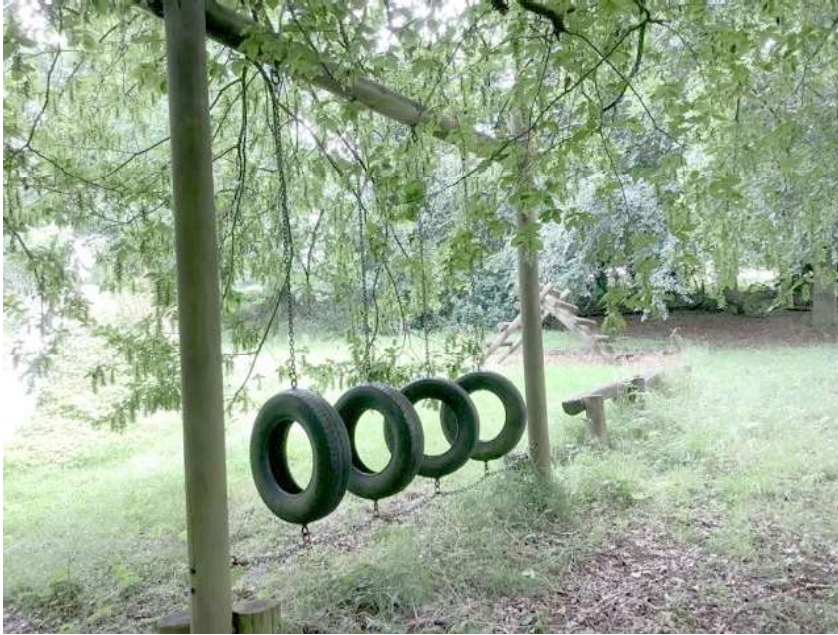
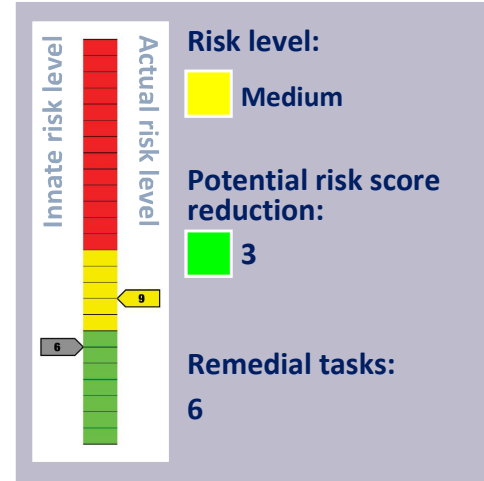
# Agility - Trim Trail

Loose in ground.

Stepping posts are loose in ground. Reset.

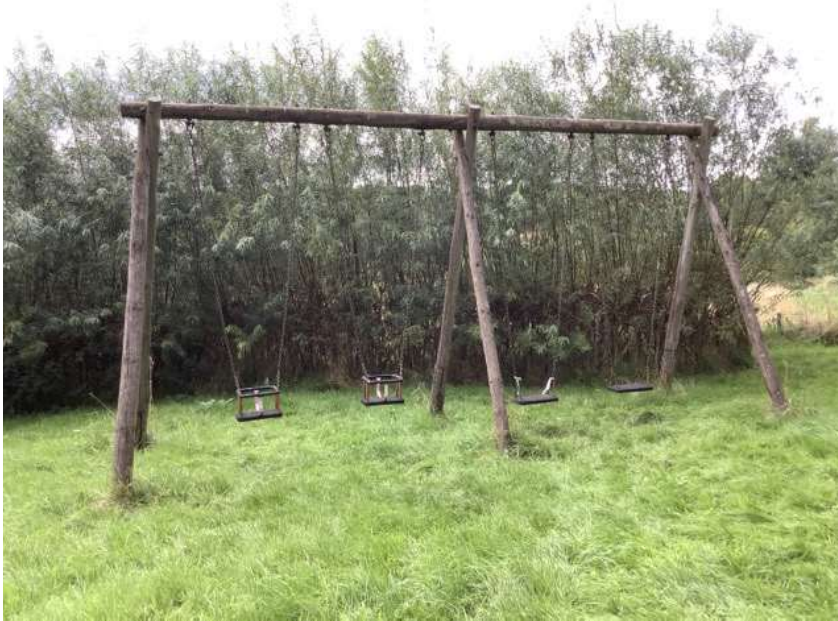
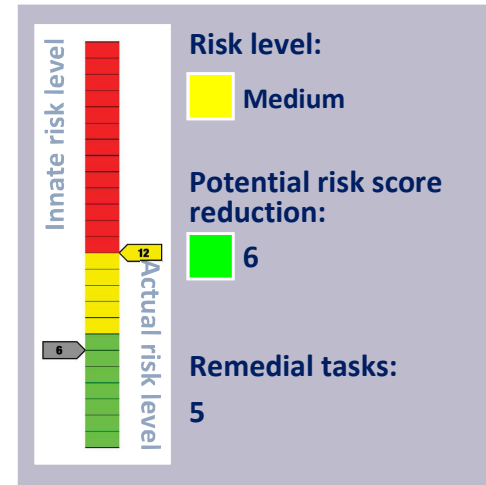
# Swing - Mixed - 2 Bay 2 Junior 2 Toddler Seat

Timber is decayed.

Top beam has various parts that sound dull when tap tested. Monitor for structural stability and replace when necessary.

Timber is not in good condition.

A number of significant repairs have been undertaken including splicing in replacement lower legs. There will be a requirement for the operator to check all timber supports and top beam on a routine basis.
